- Site Report -

Project Name/Location: LTPP Deming, NM

Job Description: Communication Lost with Site

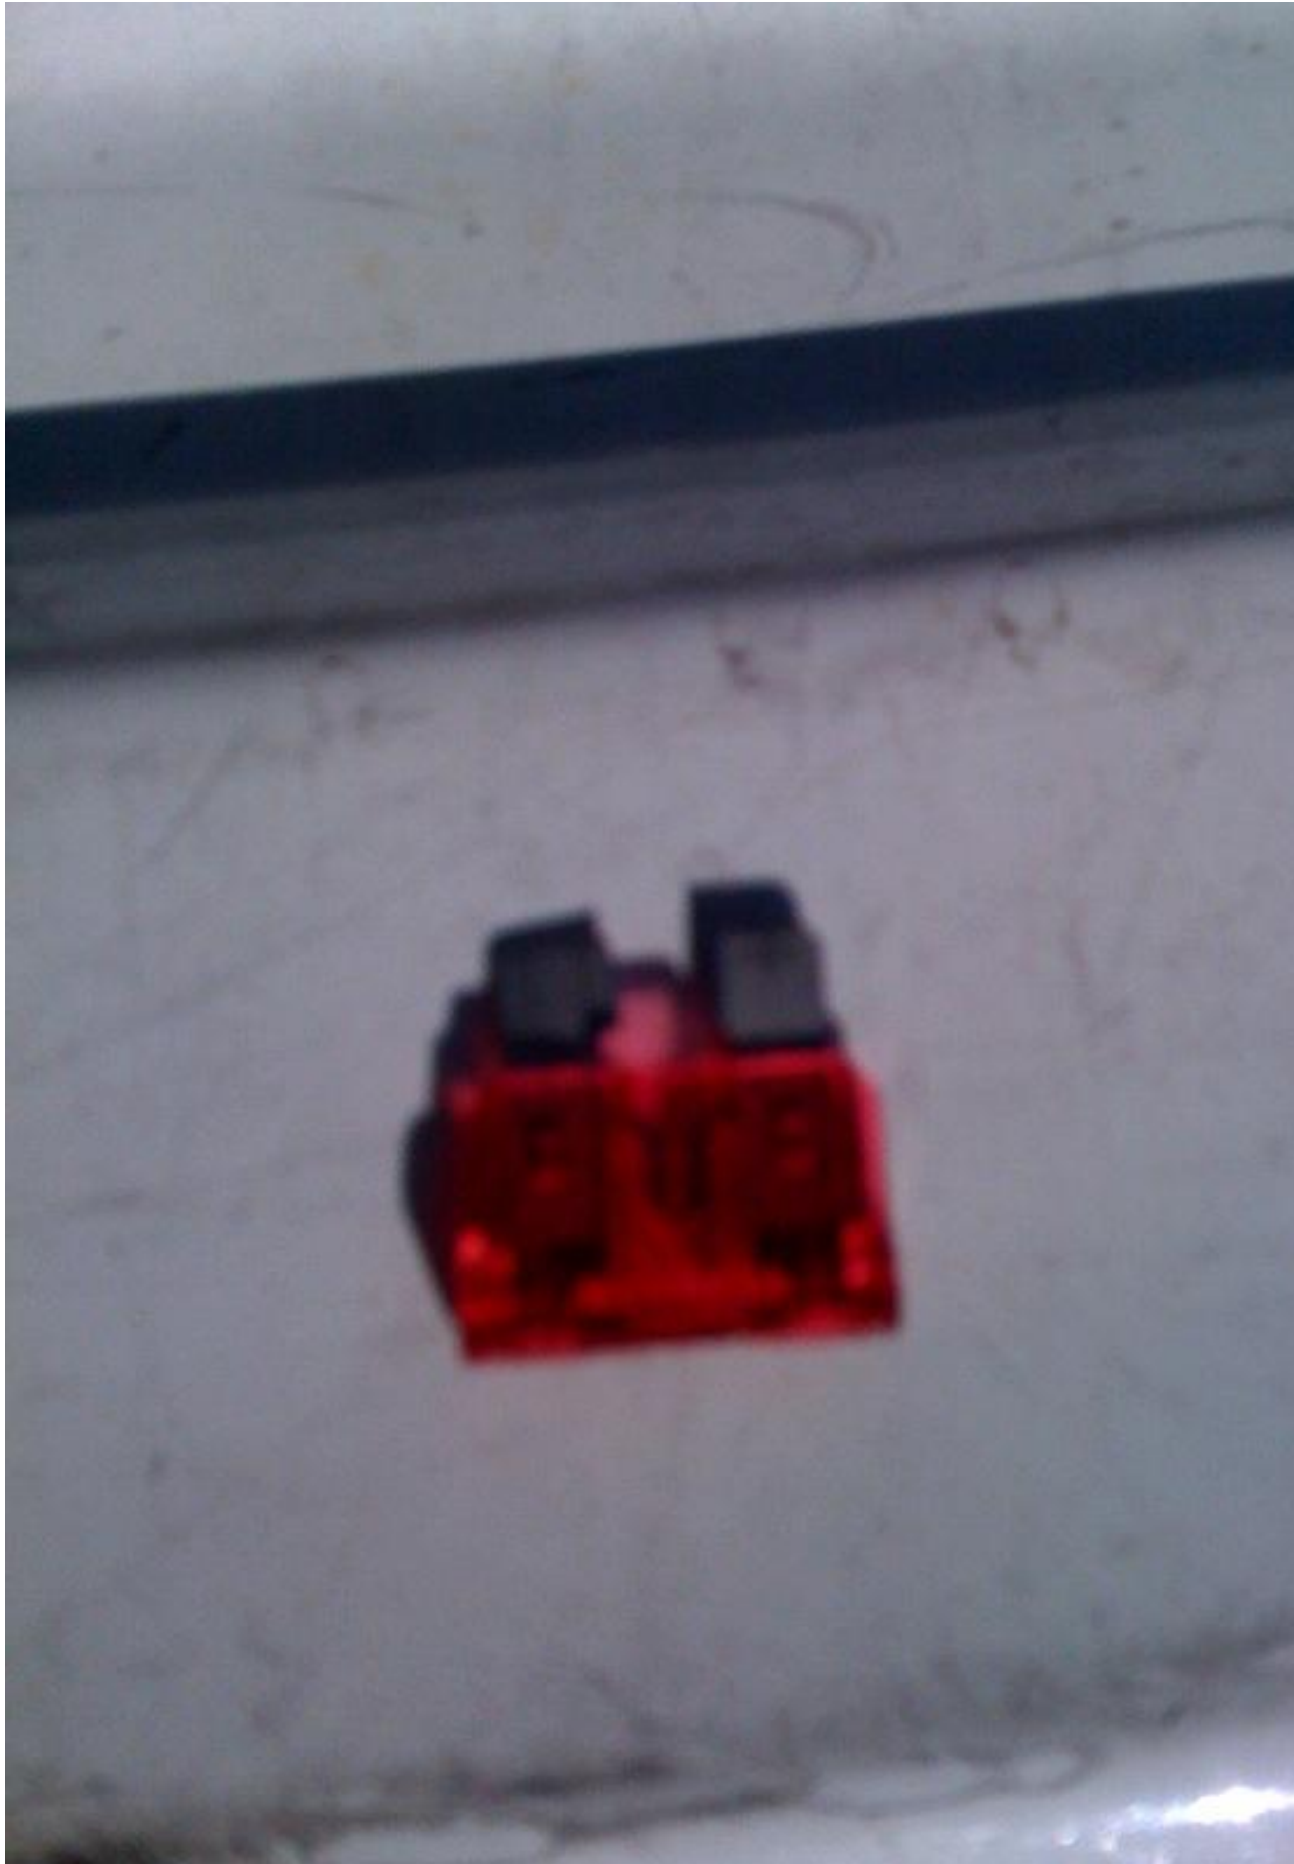
- Arrived onsite and found no power at cabinet.
- Troubleshooting led to a blown 10A isolation fuse. Replaced fuse and power restored.
- ISINC powered up normally. Logged onto site and verified sensor operation OK.
- Verified Solar Battery Charger operating normally: Battery 14.4V, Solar Output 3A, Load .3A.

Parts Used: 1x 10A Fuse
